DESKTOP STUDY & CONDITION ASSESSMENT OF GOODWOOD ISLAND WHARF

Port Authority of New South Wales

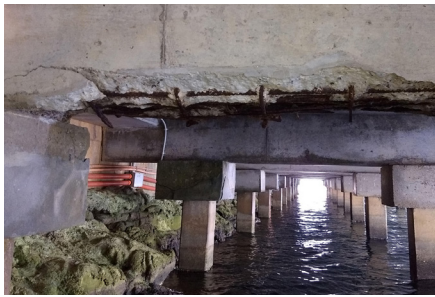
Under the wharf, extensive concrete deterioration and exposed reinforcement.

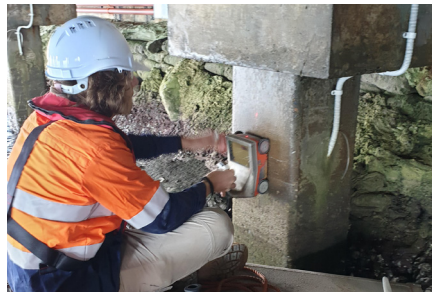
Testing on site as part of the investigation.
