# FACADE CONDITION ASSESSMENT AND REMEDIATION

595 Collins Street, Melbourne

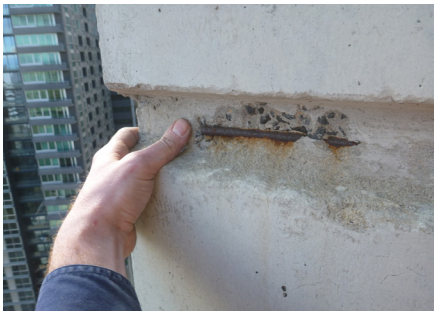
The concrete cover to reinforcement had been significantly reduced due to the presence of architectural false joints.

The carbonation front had already advanced deeper than reinforcement in some locations and concrete spalling (due to reinforcement corrosion) was occurring. As corrosion initiation had occurred, it was considered likely that a protective anti-carbonation coating alone was insufficient to manage the risk of further corrosion and resultant concrete spalling.

A robust solution which involved the installation of galvanic anodes and application of an anti-carbonation coating, was adopted. This method would enable the building owner to conduct the façade works in a single project, rather than stage repeat works at regular intervals, and provide a maintenance free period of up to 20 years.

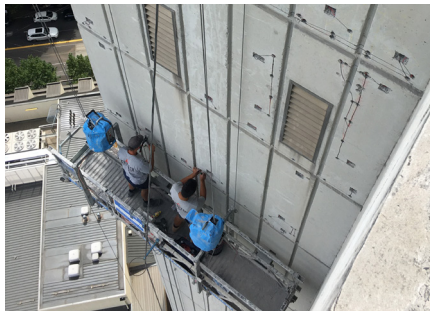
Façade repair works (including installation of galvanic anodes) were conducted via swing stage.

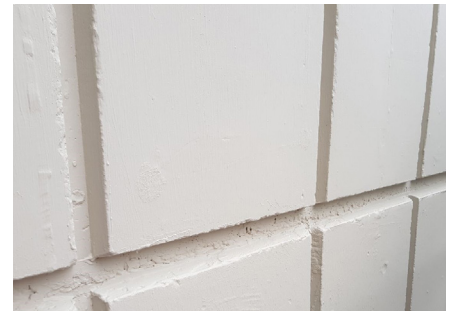
Finished facade with installation of galvanic anodes and anti-carbonation coating to maintain aesthetic appearance.
