## AN EFFECTIVE TREATMENT FOR AN ASR-DAMAGED RAIL BRIDGE

Strathfillan Creek Bridge, Victoria

CLIENT: V/LINE PTY LTD

## STRATHFILLAN CREEK BRIDGE RECTIFICATION WORKS

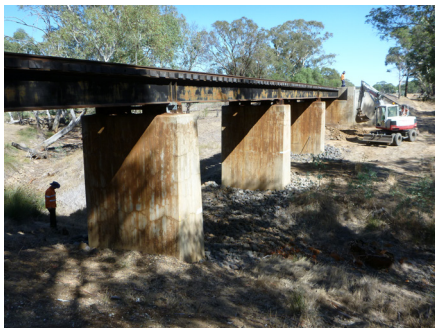
The Strathfillan Creek Rail Bridge lies on the Dunolly - St Arnaud rail line. The bridge has four spans each approximately 9 metres in length. The three bridge piers and the two abutments are constructed predominantly of unreinforced concrete, which were suffering from severe Alkali Silica Reaction (ASR) induced cracking, commonly known as 'concrete cancer'. V/Line required a remediation treatment to be designed to stabilise the deterioration.

The Strathfillan Creek bridge before works.

- Extensive crack repairs via epoxy injection;
- The installation of 'Near Surface Mounted' (NSM) Carbon Fibre Reinforced Polymer (CFRP) Plates;
- Encapsulation of the piers with a CFRP Wrap to provide added support; and
- Application of waterproofing coatings to minimise moisture penetration and thereby slow the progress of ongoing ASR.

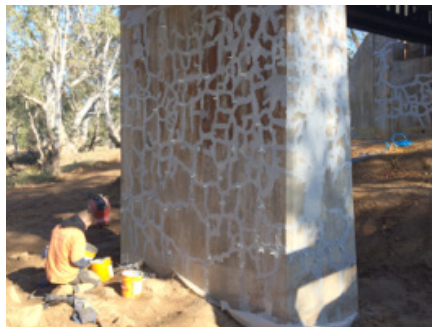
Concrete column prepped for crack injection.

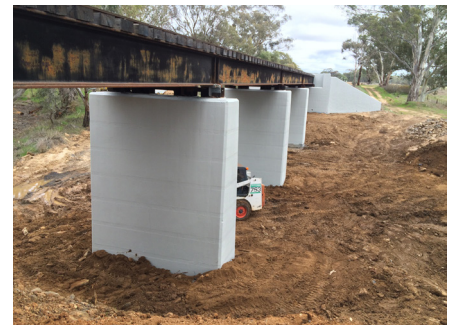
The bridge after the completion of works.
